Minimizing Seam Puckering on Stretch Woven Fabrics

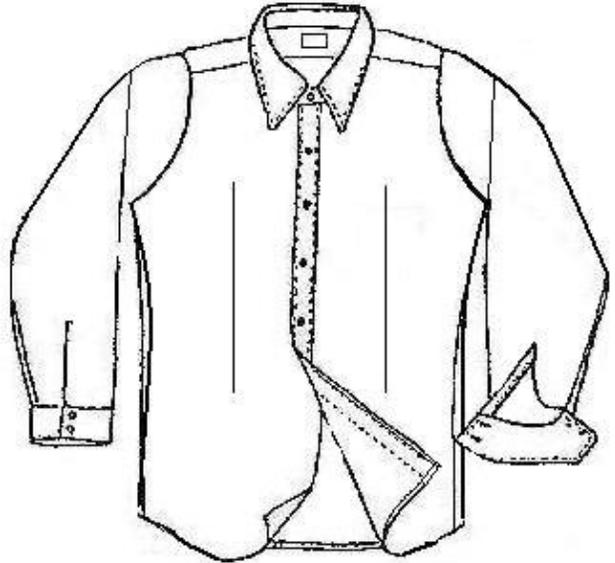
Many times, the puckering in stretch-wovens is a result of trying to sew these fabrics using the same seam constructions and on the same sewing machines that are used for non-stretch woven fabrics. Standard woven fabrics usually do not have much stretch in the warp or weft seam directions and have only marginal seam stretch in the bias direction. On the other hand, stretch-woven fabrics, have much more stretch in the warp and weft seam directions and a significant amount of stretch in the bias direction. Due to this physical difference in the stretch fabrics, seam puckering is much more of a problem on stretch-woven garments, particularly on seams that run on the bias.

Examples would be on Sleeve Set, Close Sleeve & Side, or Dart Front Panel operations. Also, the more complex the seam construction, the more pronounced the puckering will be. If the sleeve is attached with only a safety stitch (ISO-516) stitch and seam construction, there will be some signs of seam puckering in the bias but far less than more complex seam designs.

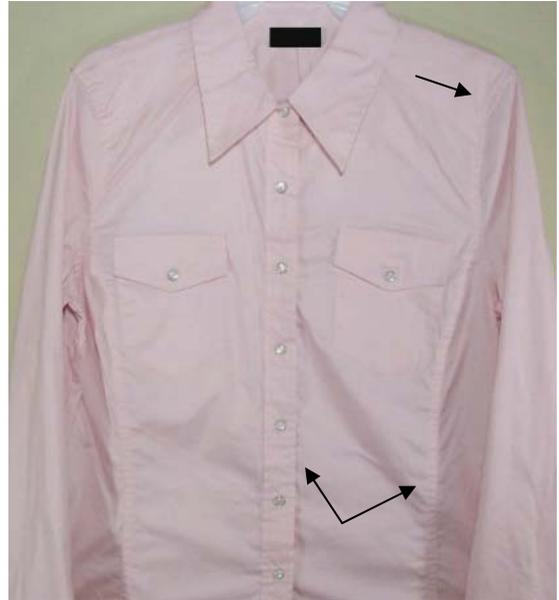
Complex Seam Constructions – Felled Sideseam

If a Felled or French-Felled seam construction is used for Side Seaming, using two rows of chainstitch (ISO-401), the seam puckering will be very pronounced.
